Templeton-Whitney Grazing Allotments, Golden Trout Wilderness

Head Cut and Photo Point Monitoring, 2003 and 2010 (DRAFT)

By: Casey Shannon, Hydrologic Technician

Inyo National Forest, Supervisor's Office

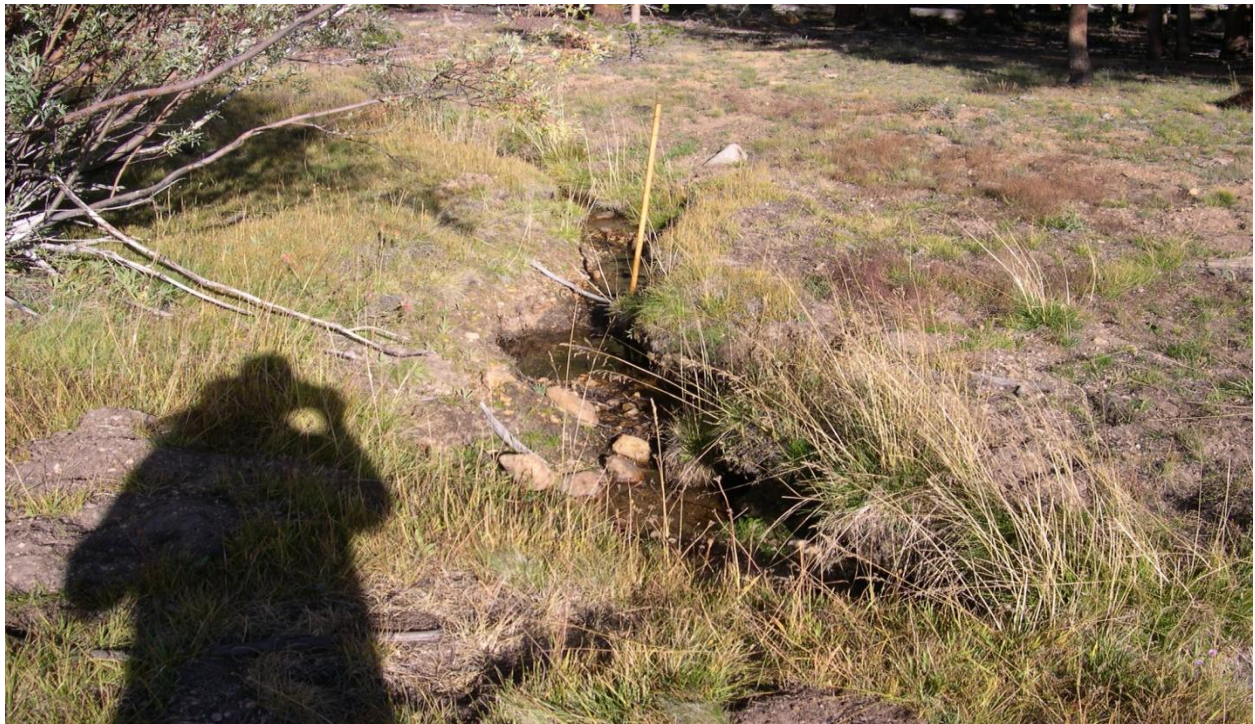
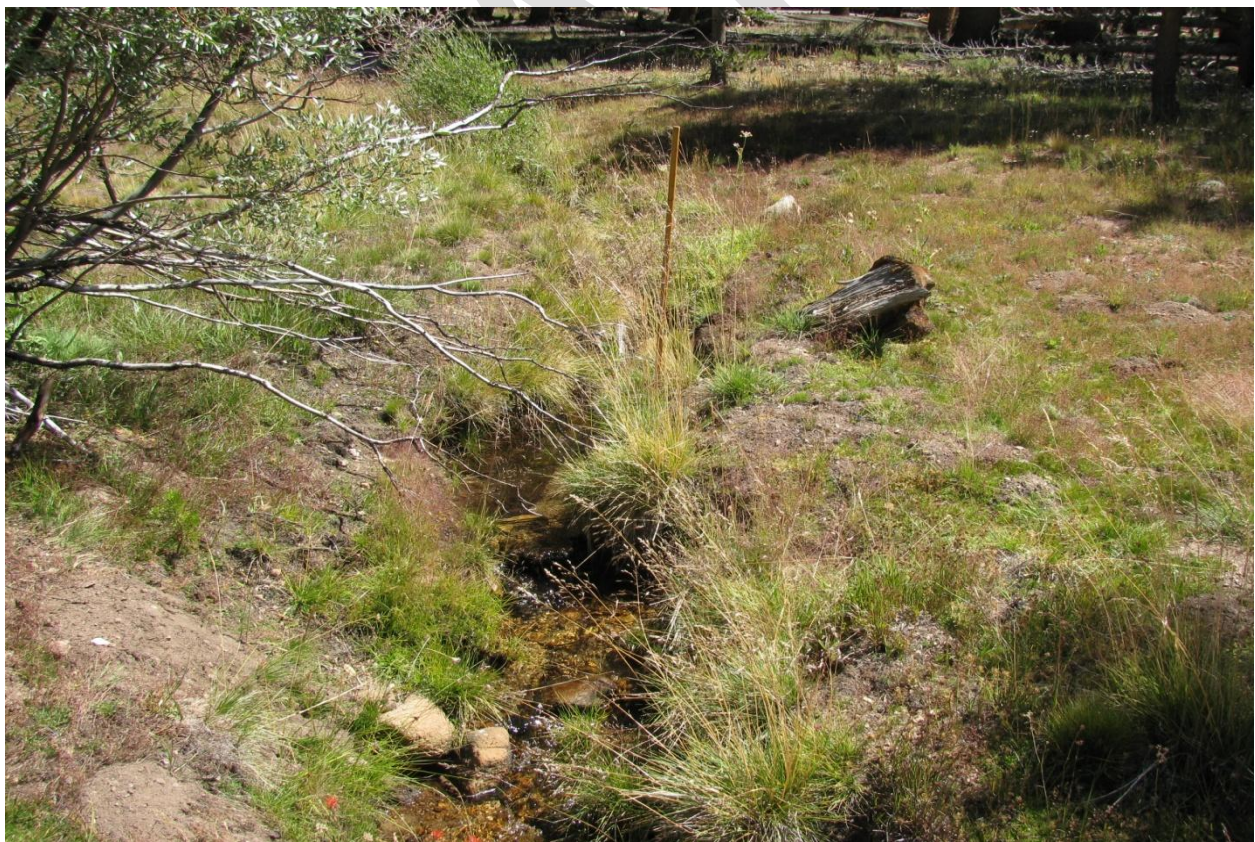
Above photo: Photo point 379 1A (PP 378 1a) aka 1999 PP 17, Stokes Stringer Section 2, September 2003. Small head cut where meter rod is seen in photo. **Below photo:** PP 378 1A Stokes Stringer Section 2 photo retaken September 2010. Head cut is controlled by existing grade and form of channel and no longer is migrating. Bank vegetation has increased and channel has narrowed and stabilized. No issue.

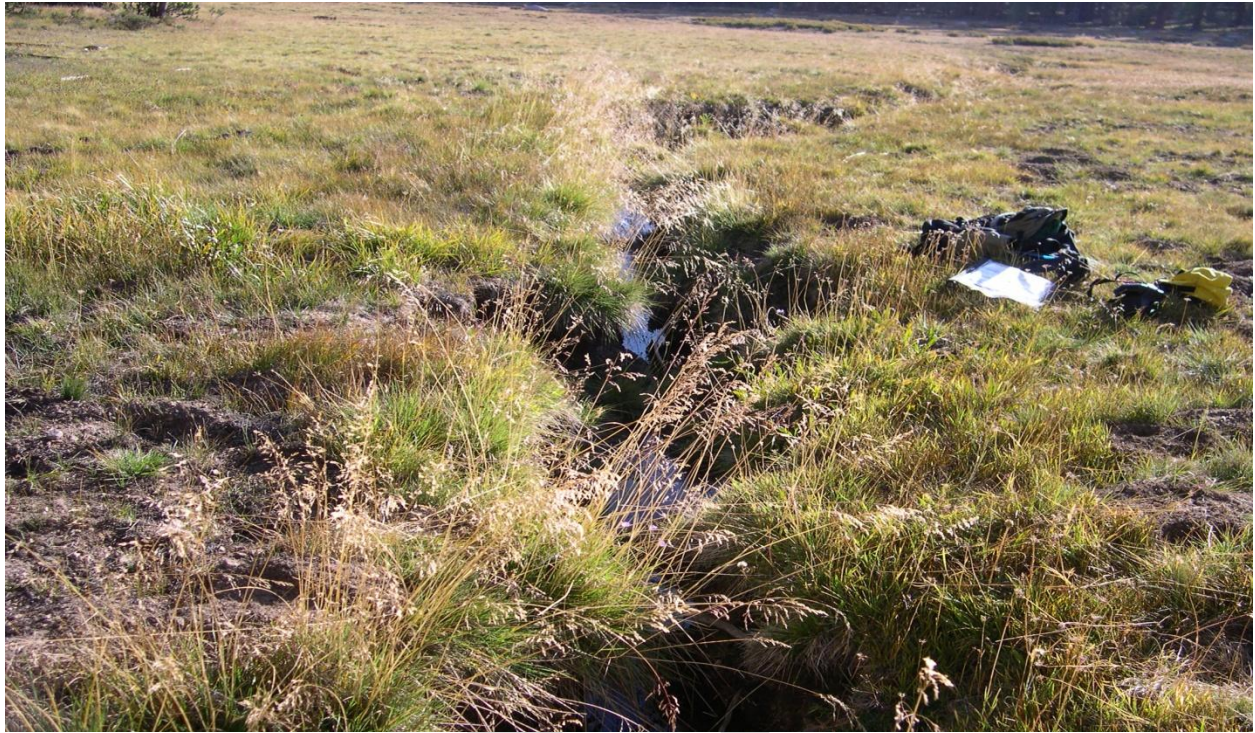
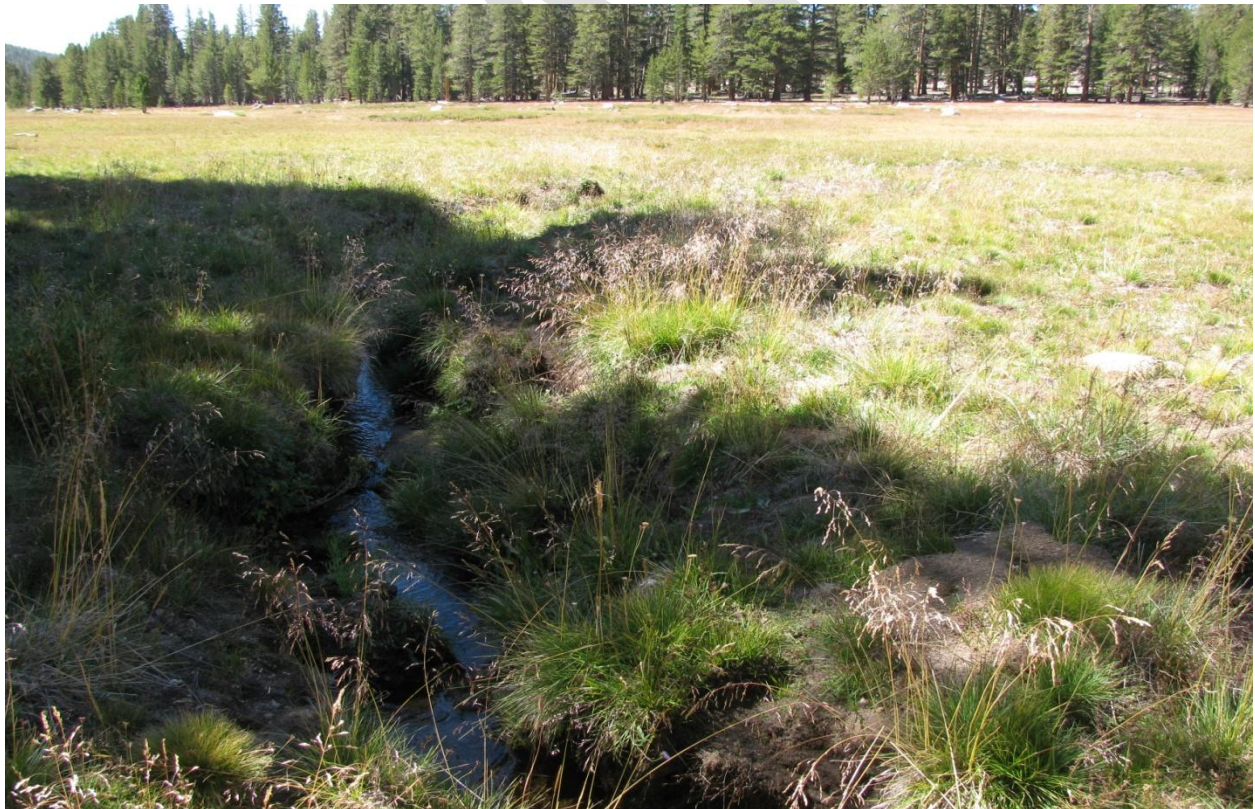
Above photo: Photo point 379 1B (PP 379 1B) aka PP 17 1999 Stokes Stringer Section 2, September 2003. Looking down incised channel below head cut to meadow. **Below photo:** PP 379 1B Stokes Stringer Section 2 photo retaken September 2010. Incised channel is showing slight to moderate aggradation, increased vegetation on banks is providing stability and narrowing channel.

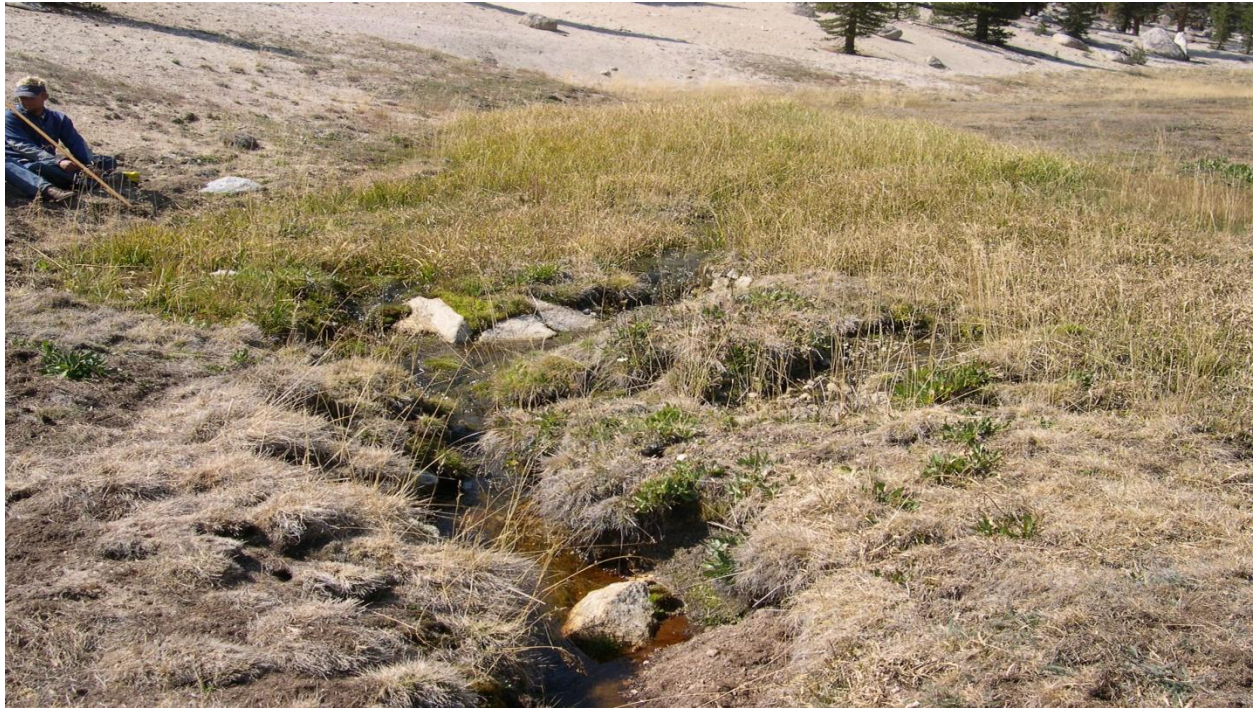
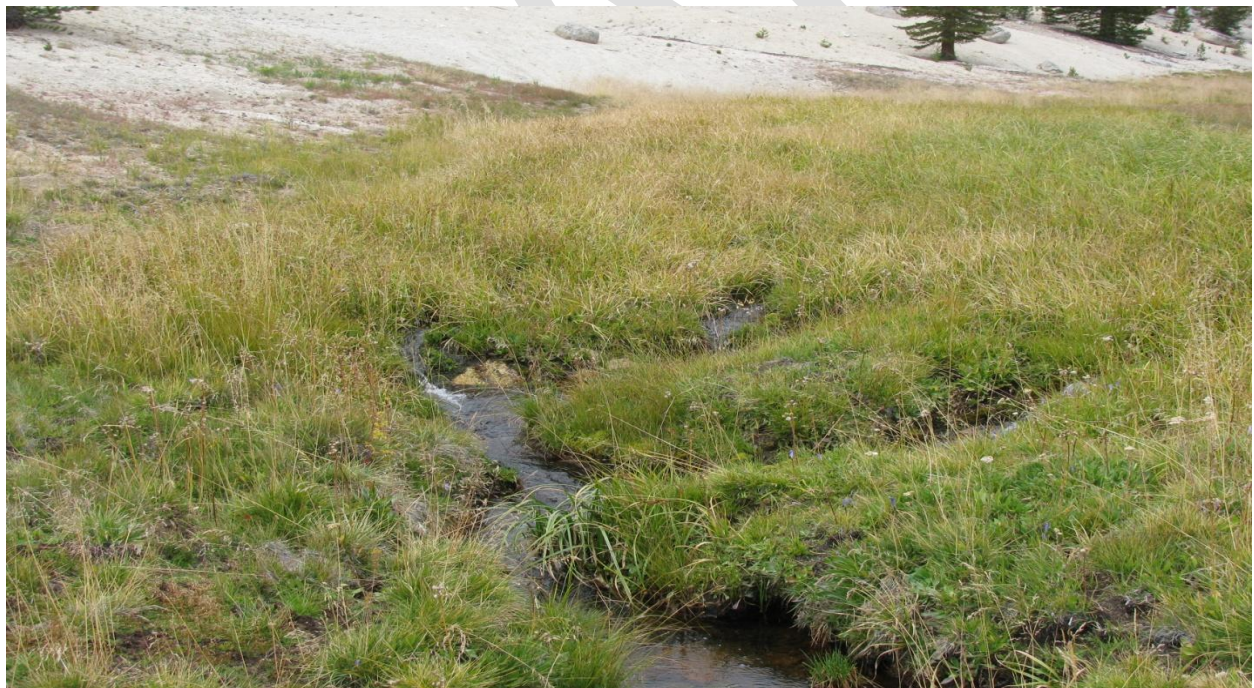
Above photo: Treated Head Cut 88 (THC 88) Big Whitney Meadow Section 1, September 2003. A rocked chute (3 chutes) treated HC sloped back with inka-mat filter cloth underlayment installed in 1999. At this time the structure and prescription was working very well, no need for maintenance. **Below photo:** THC 88 Big Whitney Meadow Section 2 photo was retaken September 2010. Head cut and structure very stabilized by encroaching riparian vegetation taking hold around structure, fully successful prescription. Riparian vegetation is more robust above HC. Structure could be vulnerable to grazing disturbance.

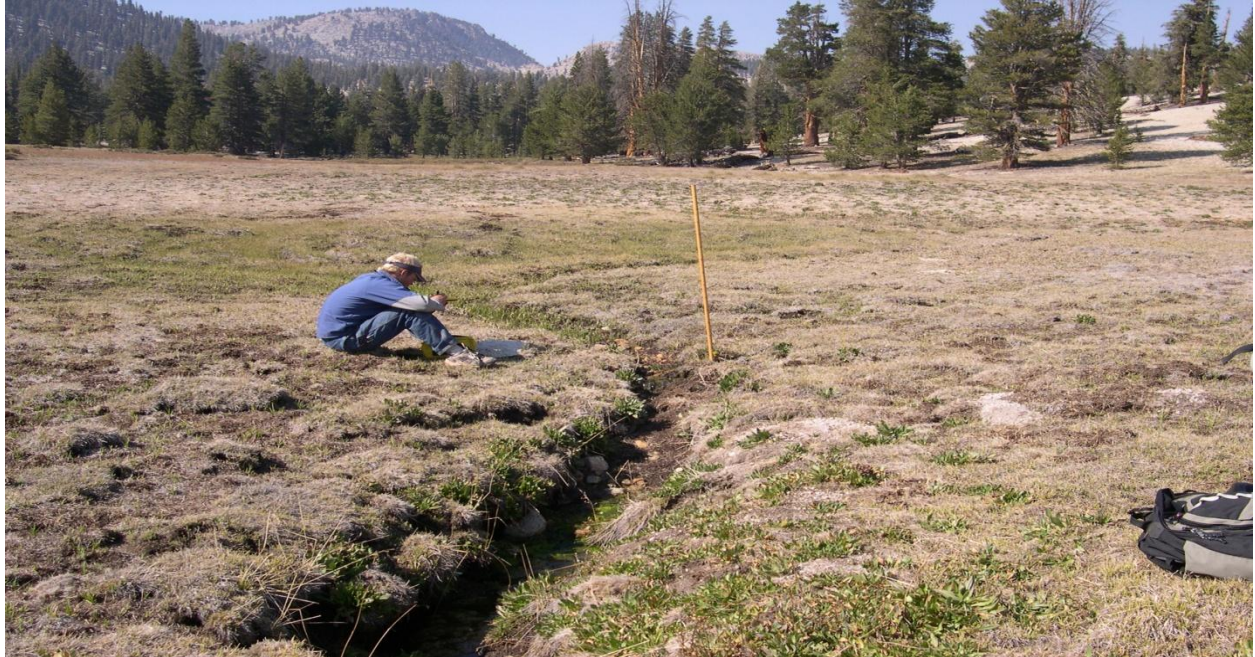
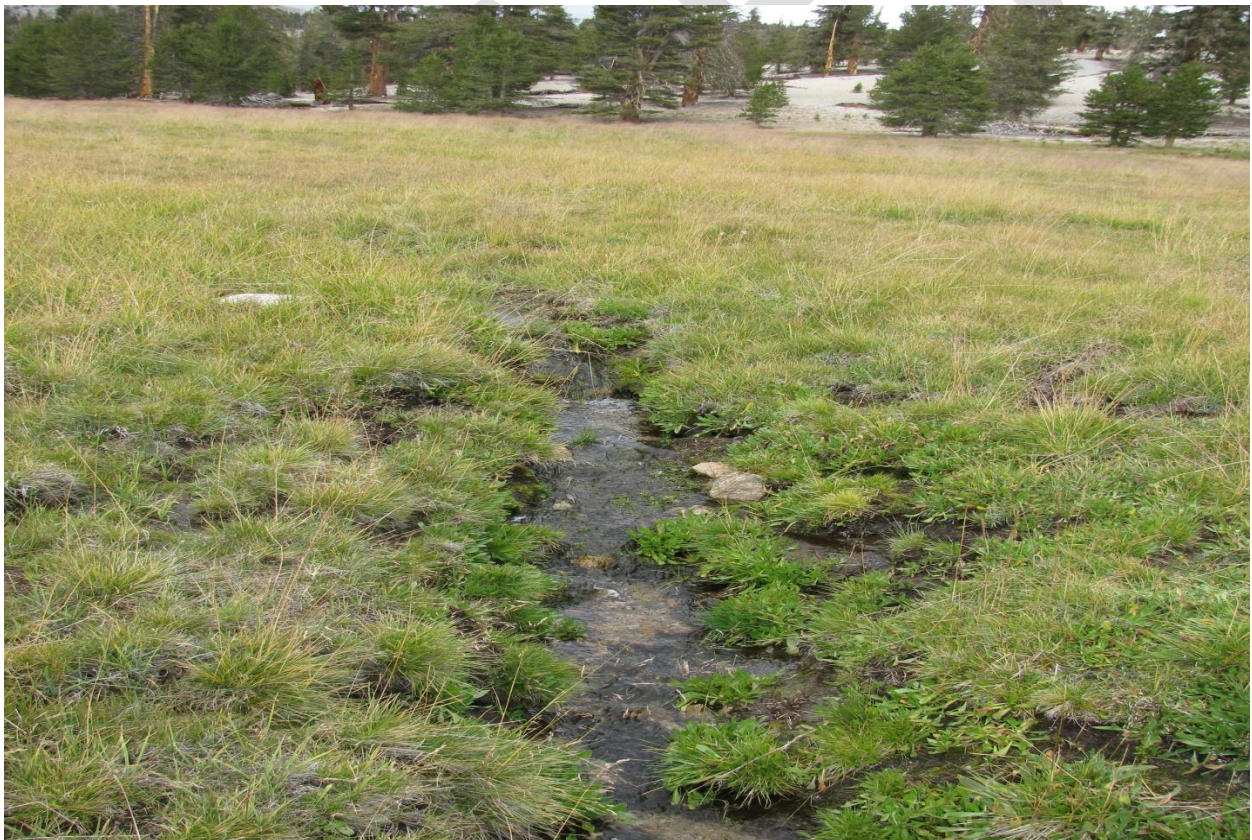
Above photo: Treated head cut 85 (THC 85) Big Whitney Meadow Section 1, September 2003. Eroded hummocks and weak vegetation is present. Structure is holding well at the time. **Below photo:** THC 85 Big Whitney Meadow photo re-taken September 2010. Channel has aggraded and robust riparian vegetation holding structure (rock chute with filter cloth) and banks. Hummocks are showing relief reduction and the water table has elevated. This is a wet site.

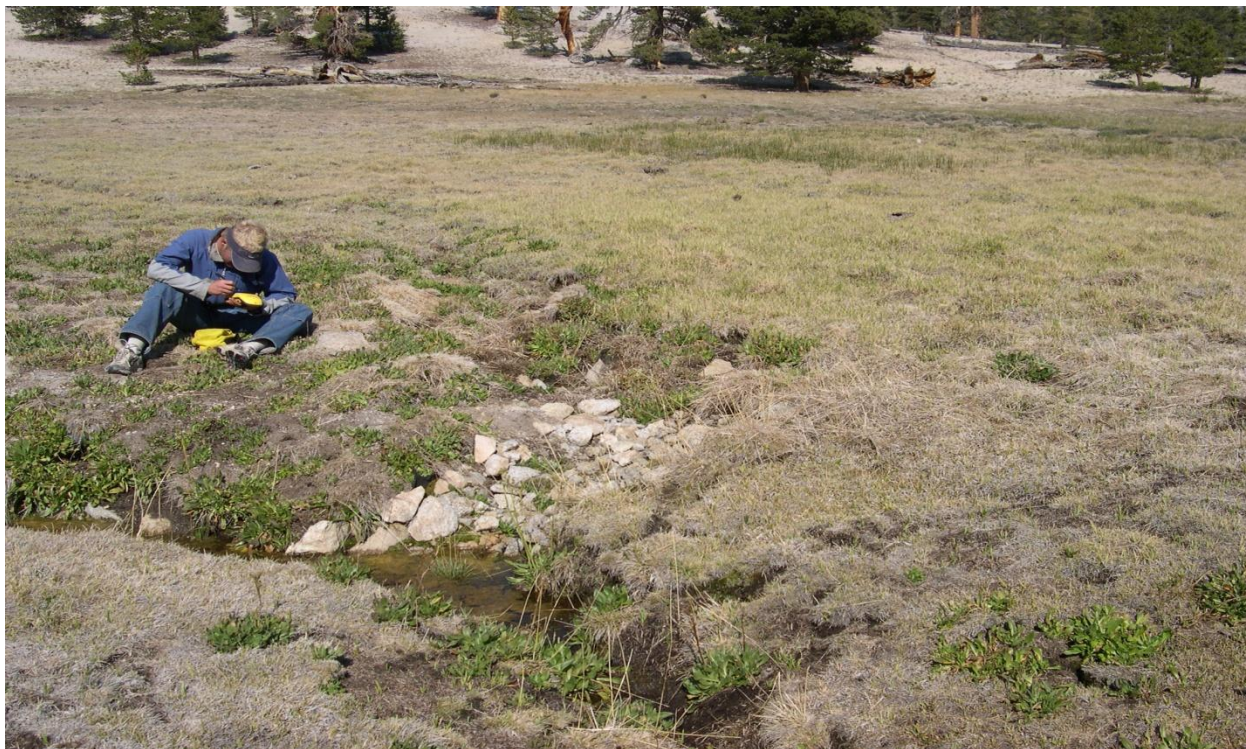
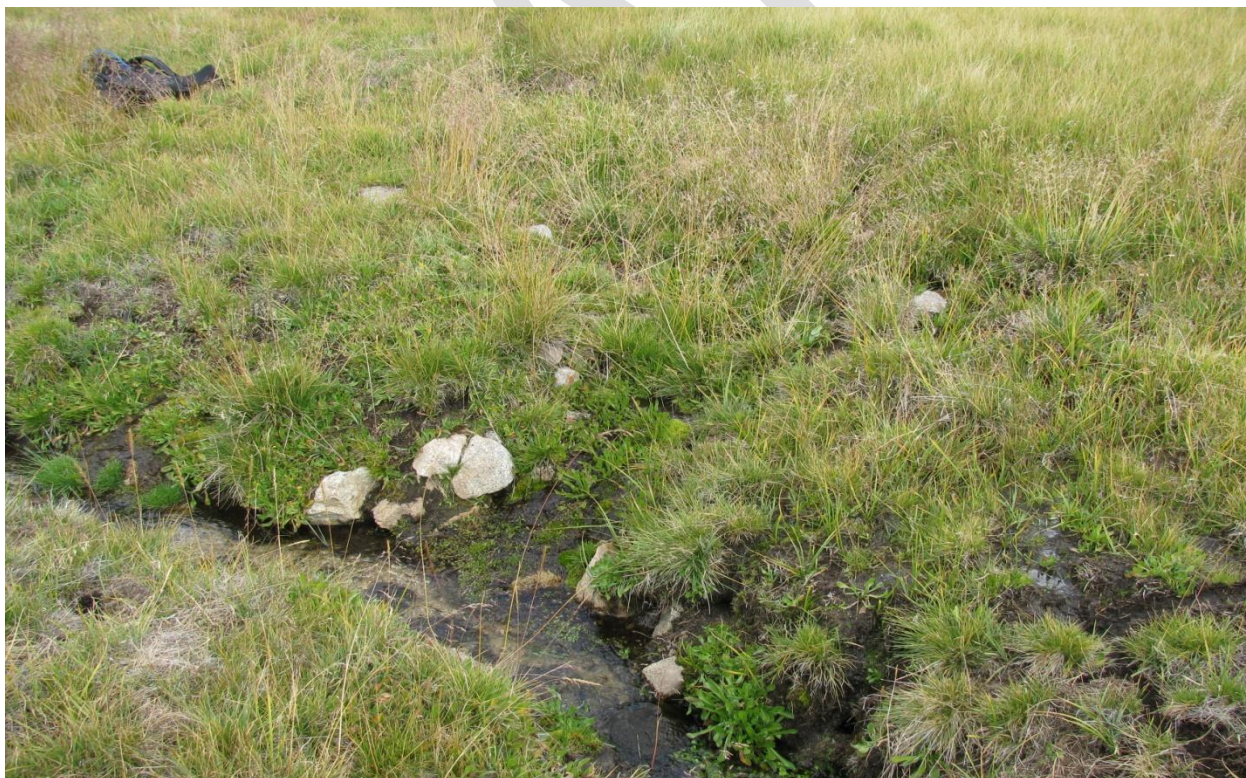
Above photo: Treated Head Cut 87 (THC 87) Big Whitney Meadow Section 1, September 2003. A rock chute/filter cloth structure is holding well. Vegetation is weaker and hummocks are present. **Below photo:** THC 87 Big Whitney Meadow Section 1 with retaken photo September 2010. Rock chute has been overgrown by robust riparian vegetation and water table has elevated. This is a very wet site that could be vulnerable to disturbance.

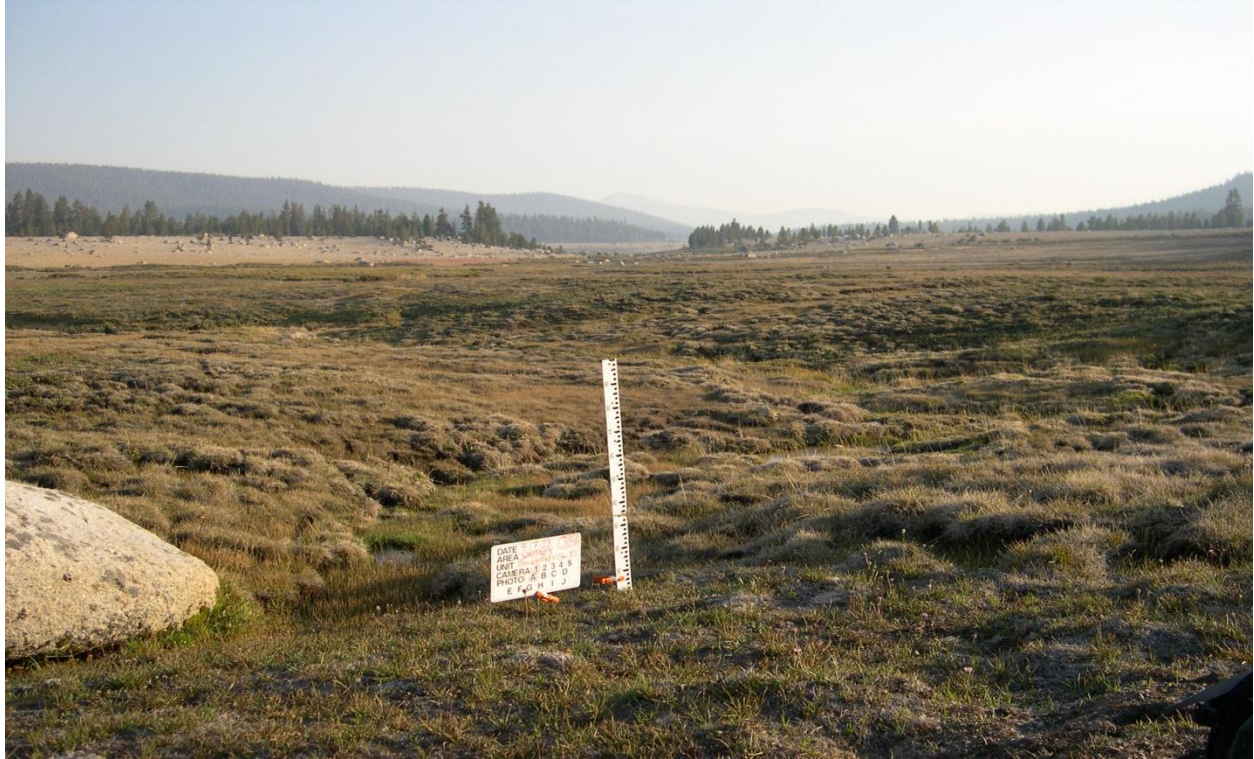
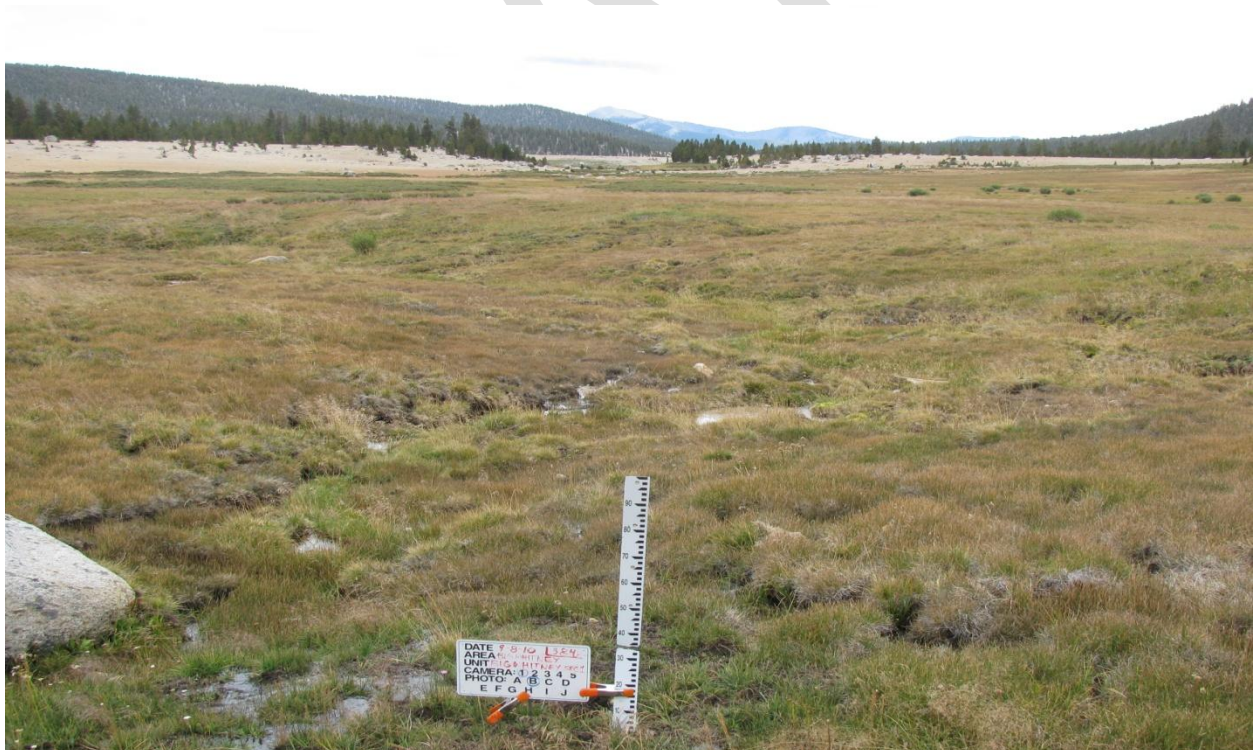
Above photo: Photo point 384 (PP 384) Big Whitney Meadow Section 1, September 2003. Broad area of hummocks and eroded soil, vegetative cover is weakened. **Below photo:** PP 384 Big Whitney Meadow Section 1 photo retaken September 2010. Hummocks are still present but have less relief and increased vegetative cover. The soil in this area is very wet, many springs and seeps exist and ground water is very shallow. This site is sensitive to disturbance.

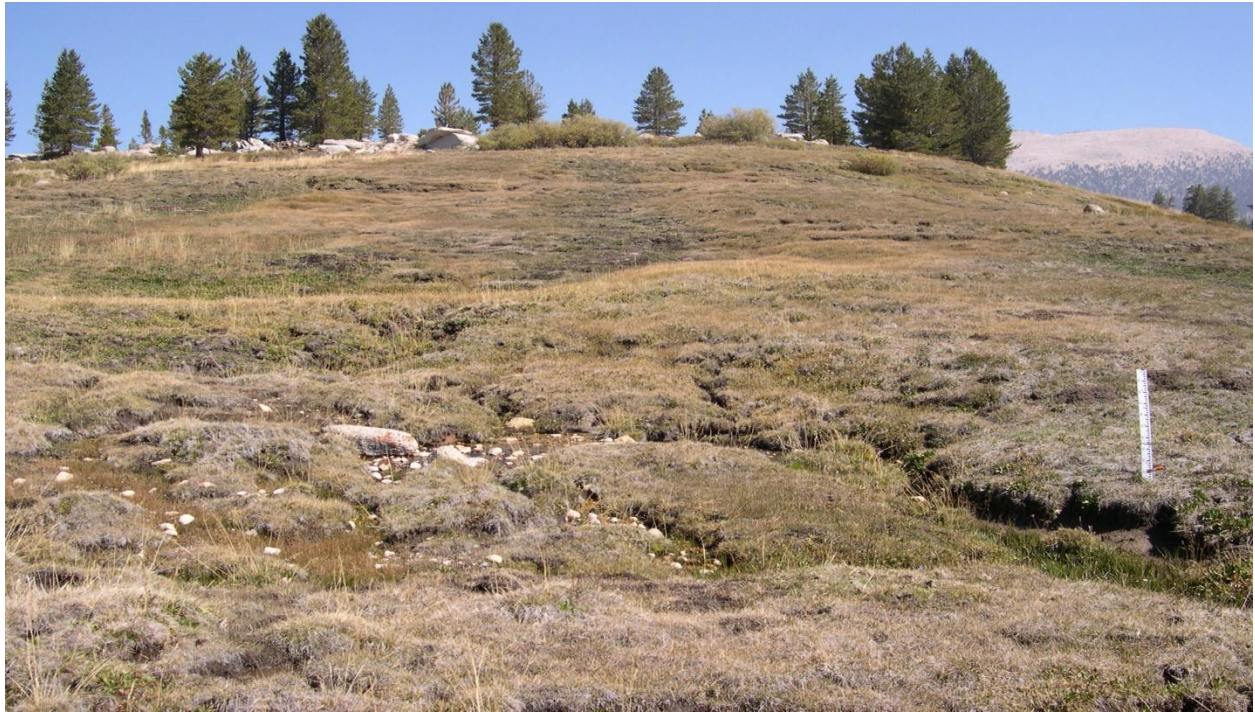
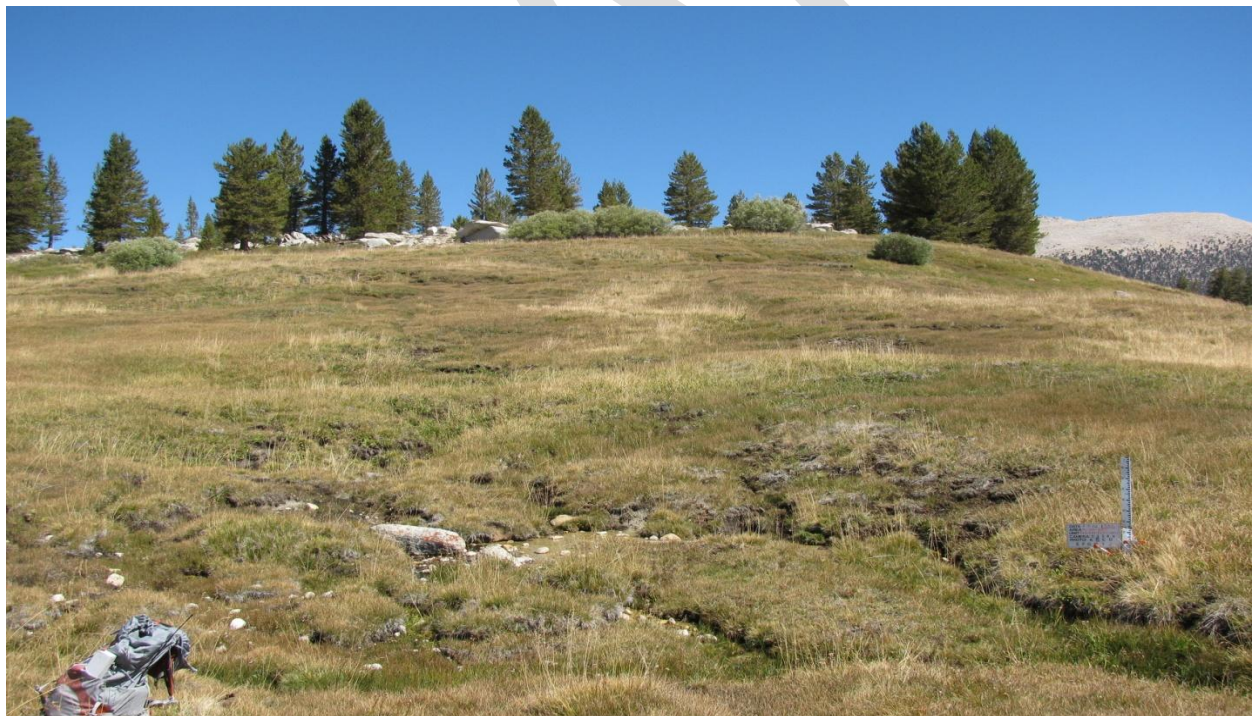
Above photo: Photo point 385 (PP 385) Big Whitney Meadow Section 4, September 2003. The site is a large area of springs and seeps and drainage channels. Hummocks cover a high percentage of the site, soil erosion is occurring along channels and hummocks. Very wet soils exist, vulnerable to disturbance. **Below photo:** PP 385 Big Whitney Meadow Section 4, photo was retaken September 2010. Hummocks have diminished moderately and have increased vegetative cover. Channels appear more stable with increased vegetation. Still very wet at site and soils are fragile.

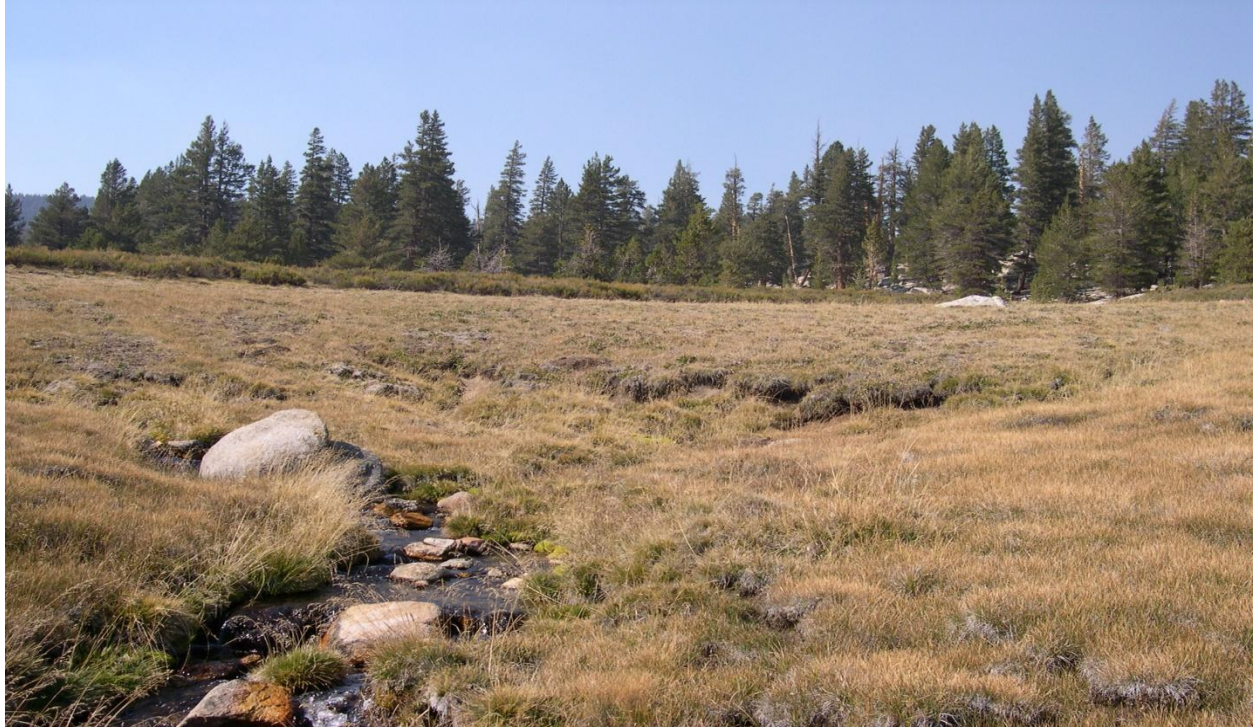
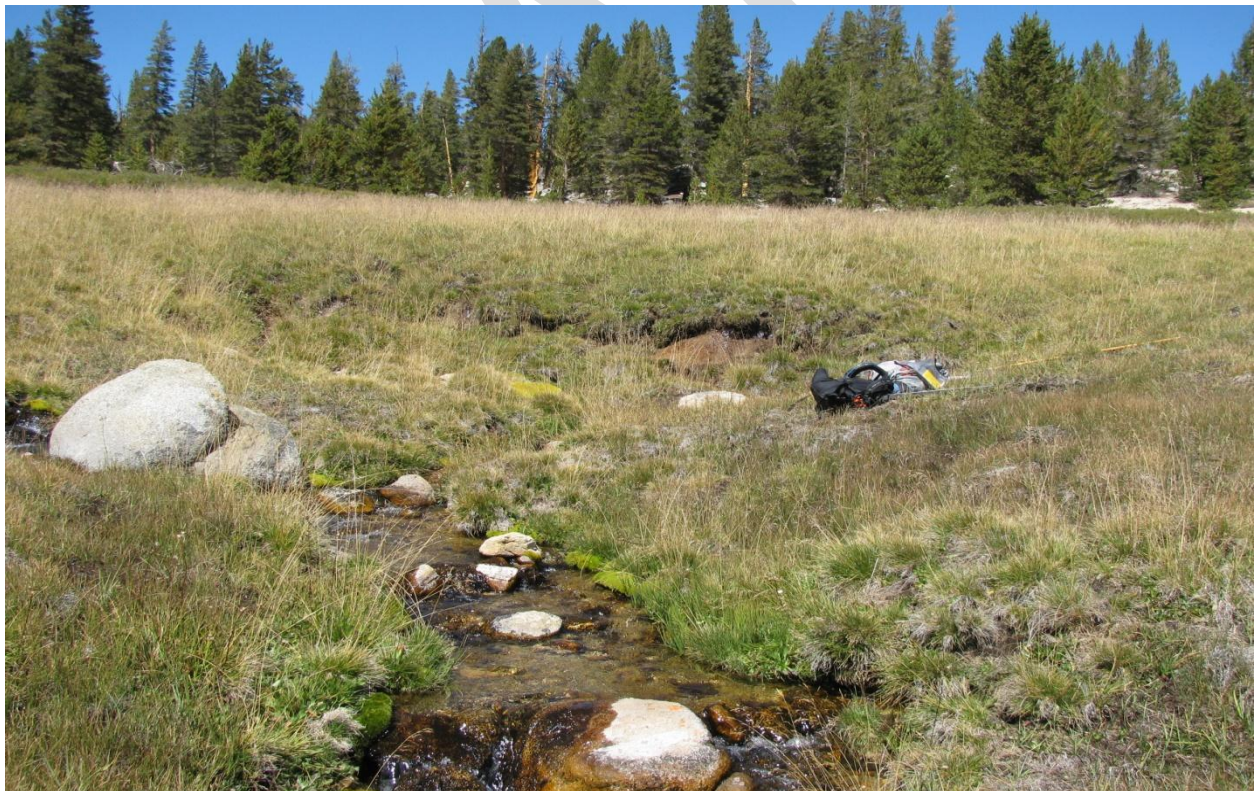
Above photo: Spring area and hummock slopes in Big Whitney Meadow Section 4, September 2003. Site is also known as photo point 9 from 1999 amendment 6 surveys. Large spring with active flow, eroded hummocks are prevalent on slopes. Soils are very wet and vulnerable to disturbance. **Below photo:** PP 9, retaken September 2010. Vegetation has increased in vigor and erosion has slowed, hummocks have lessened in size and are still prevalent.

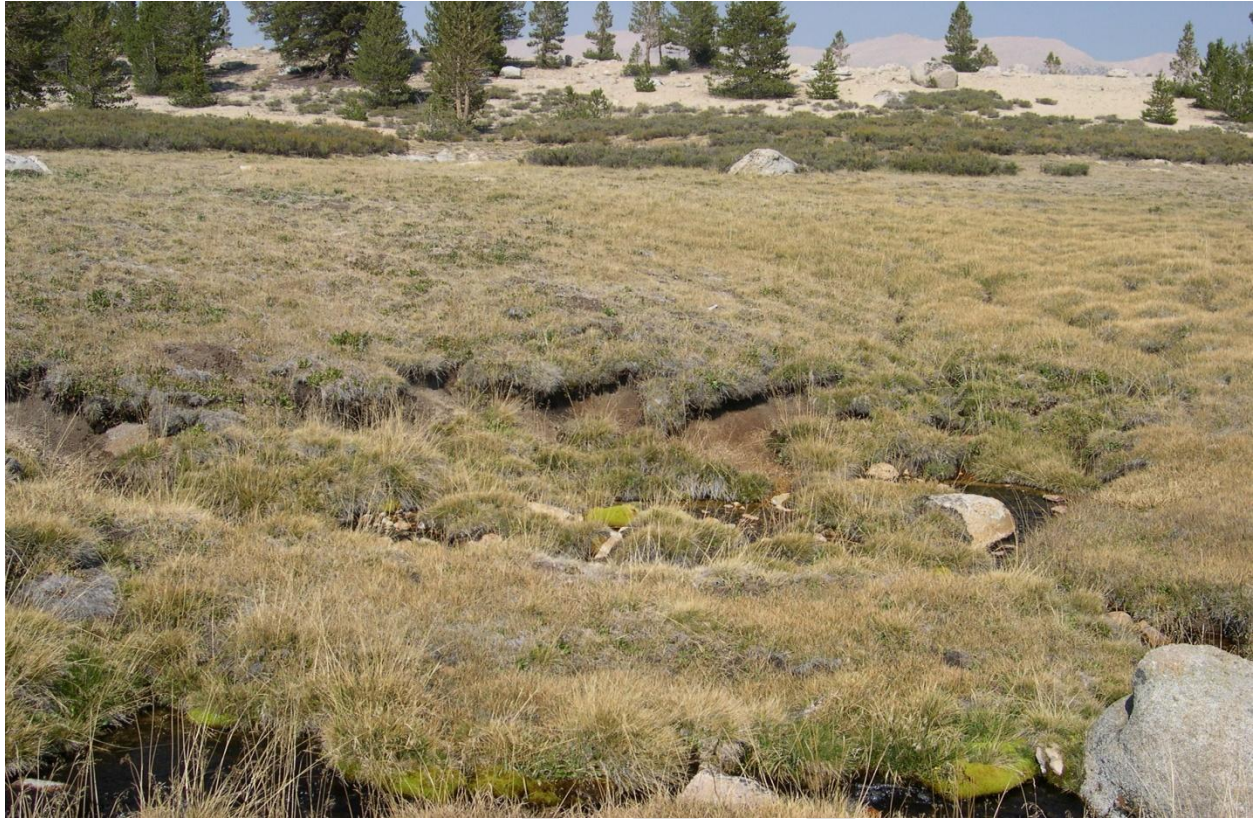
Above photo: Photo point 9, 1999 Big Whitney Meadow Section 4, September 2003 at spring and seep area. Photo was also taken in 1999. Hummocks and eroding flow pathways are noticeable and areas of bare soil.

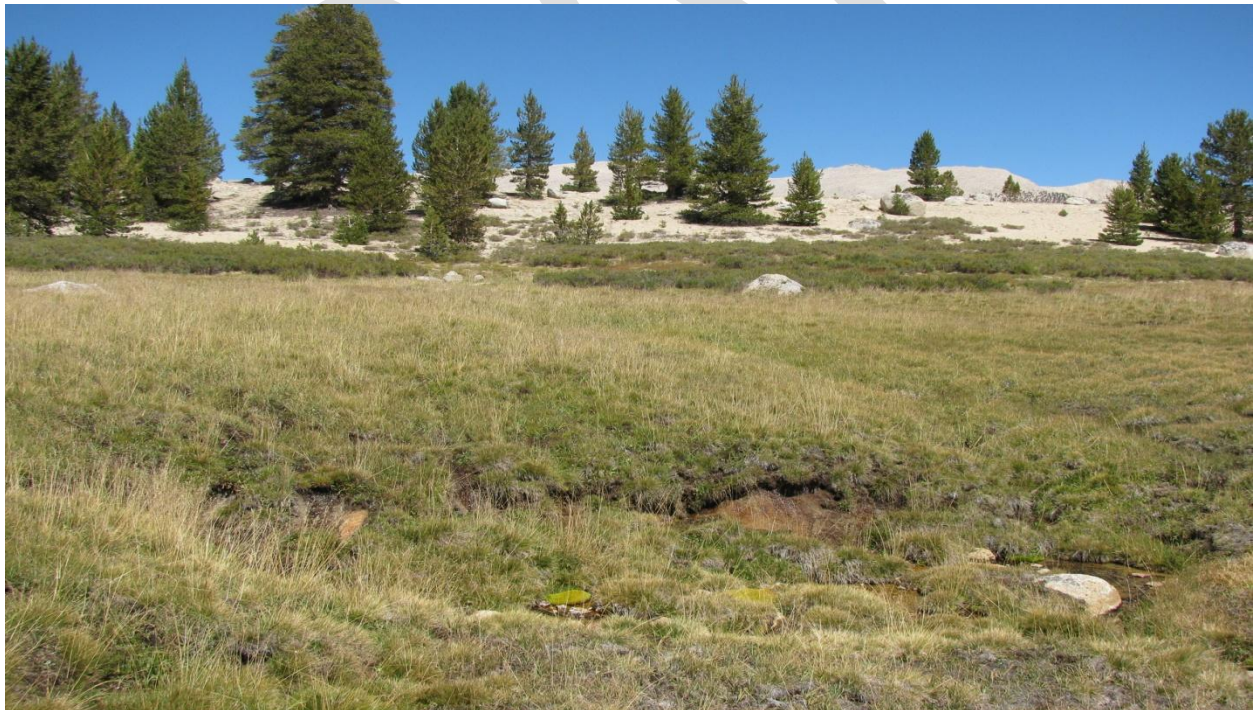
Below photo: PP 9 1999 Big Whitney Meadow Section 4, September 2010. Hummocks and rills have diminished moderately, vegetation cover has increased and bare soil areas are less but still present. This is a very wet site that is subject to impacts from disturbance.

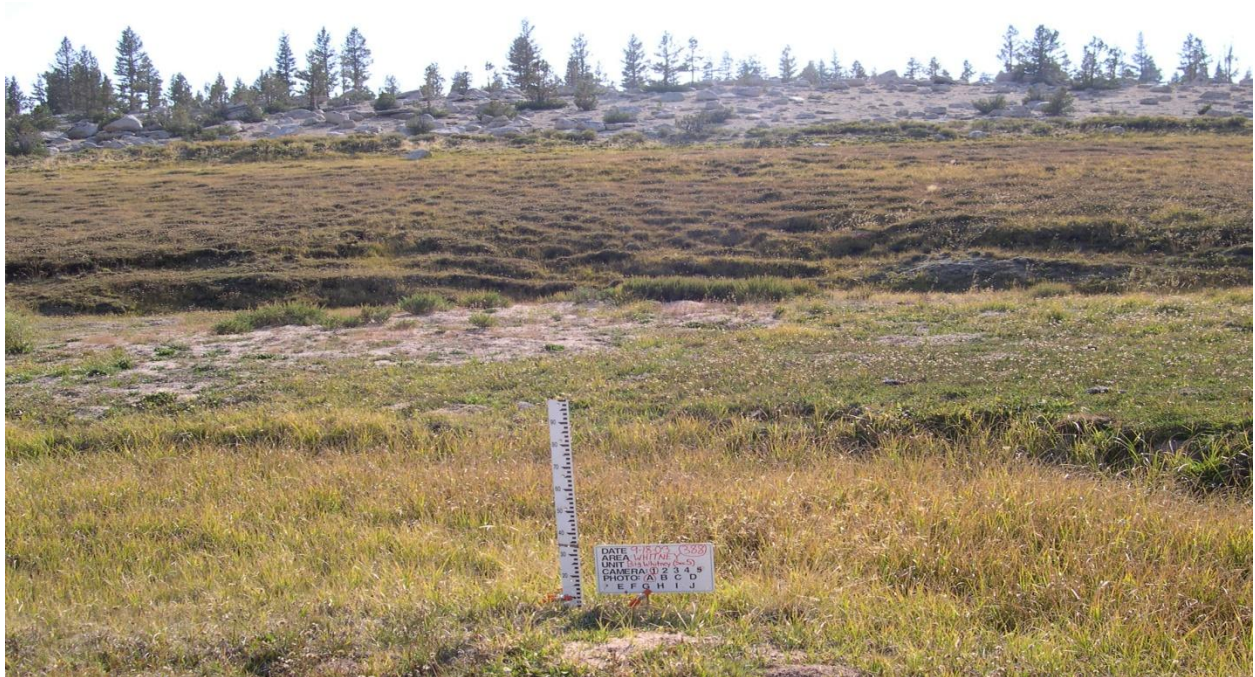
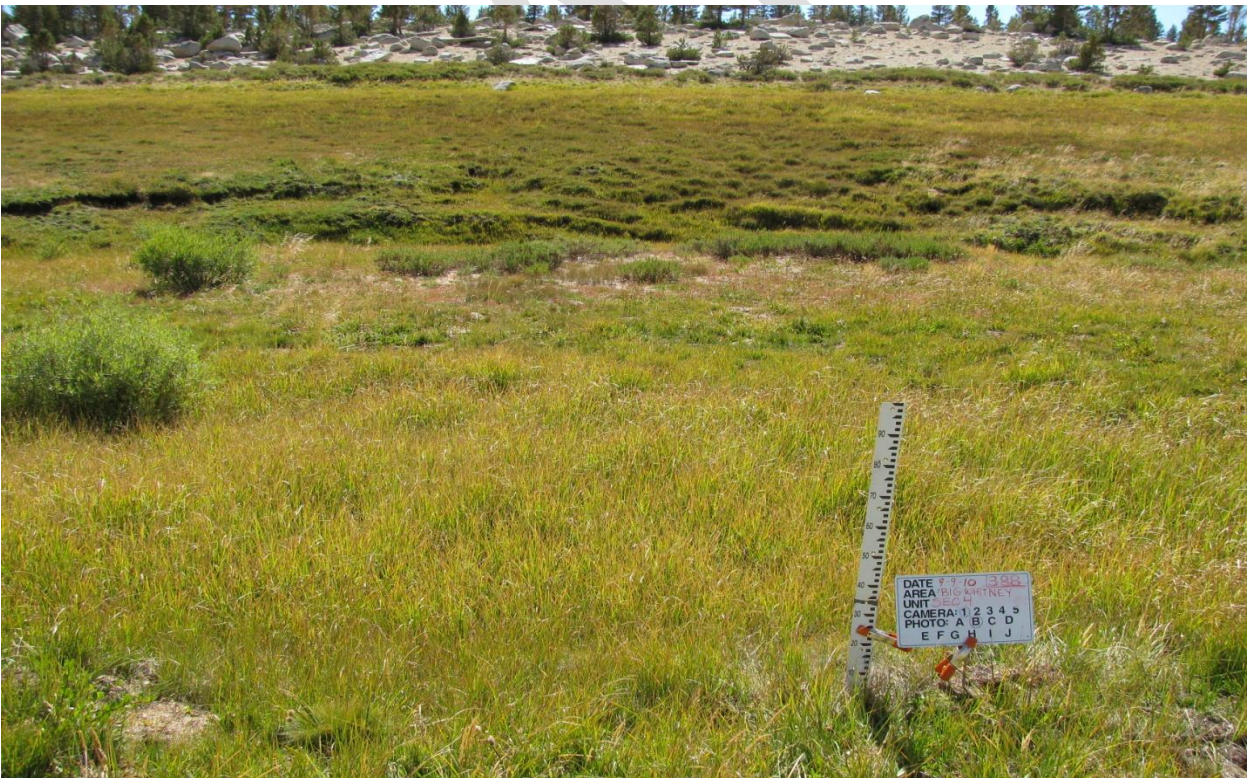
Above photo: Photo point 388 (PP 388) Big Whitney Meadow Section 5, September 2003. This site is also known as PP 11 from 1999 amendment 6 surveys. The site is a large area or swale of large, eroding hummocks and bare ground. **Below photo:** PP 388 Big Whitney Meadow Section 5, photo retaken September 2010. Hummocks have lessened in size and extent and vegetative cover has increased. Bare ground area in foreground has started to recover with growth and stability. Hummocks are still prevalent on hill slope in wet soil area.

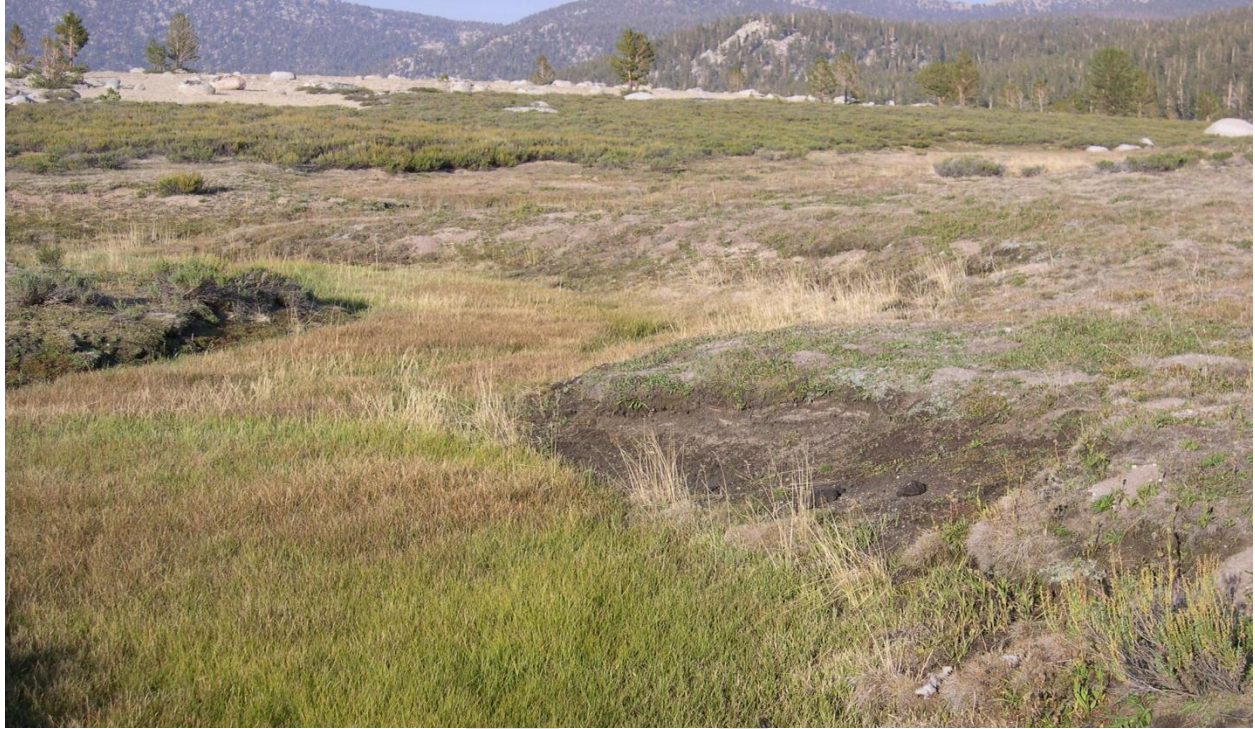
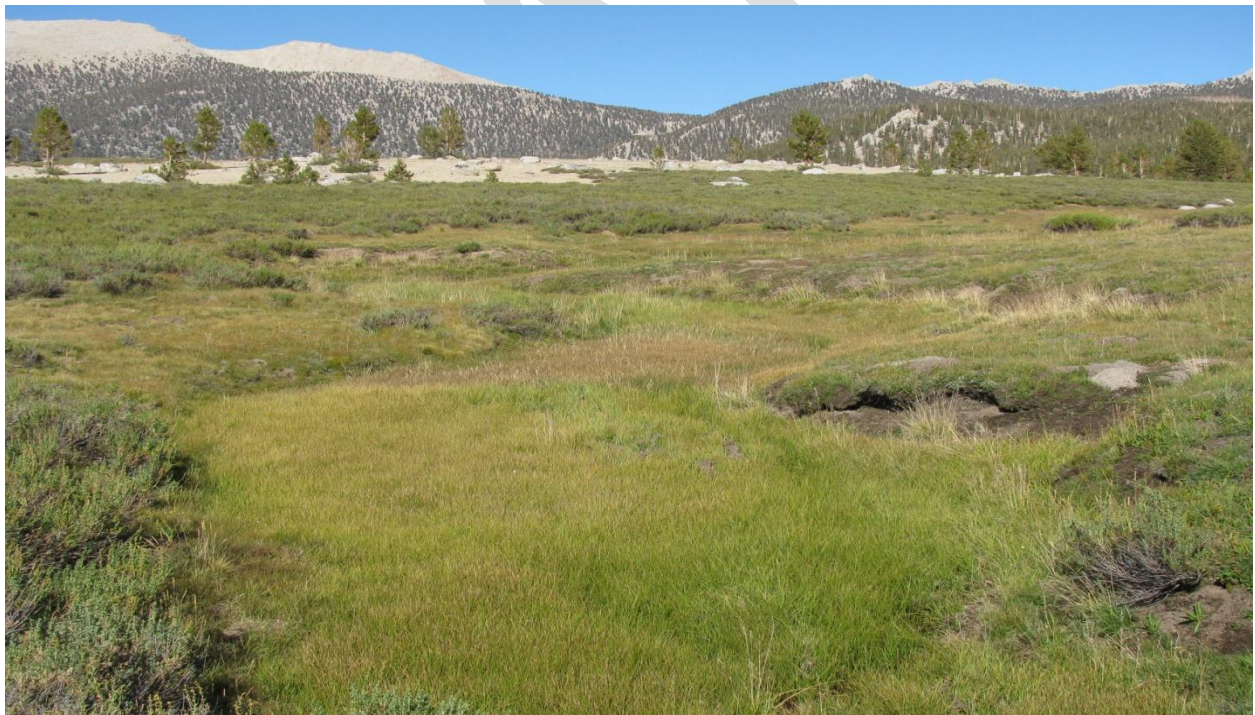
Above photo: Photo point 13 (1999) Big Whitney Meadow Section 5, September 2003. Floodplain in incised channel recovering, adjacent terrace banks have hummocks, bare ground and fragmented sod. **Below photo:** 1999 PP 13 Big Whitney Meadow Section 5, photo was retaken September 2010. Channel and floodplain have moderately aggraded and is expanding upwards to terraces, terraces and slopes are filling in with riparian vegetation and bare soil areas have diminished but still exist. Hummocks have lessened in form but are still present. Water table has elevated, site is wet and sensitive to disturbance. Floodplain vegetation is dense and well rooted and should resist impact.
